**Subject:** SVWRF Pipe & Structure

As part of the South Valley Sewer District's (SVSD) River Bottom Trunk Line Assessment - Phase 1, PEC received additional inspection videos containing a pipe segment and junction box to be assessed near the SVWRF. This pipe segment and junction box belongs to the South Valley Water Reclamation Facility (SVWRF), located at the north end of the SVSD project, see Figure 1. The pipe segment is an existing 96-inch diameter Reinforced Concrete Pipe (RCP) and the concrete junction box is divided by North and South access points. An individual pipe report and junction box report, showing the defects found, have been included as an attachment to this technical memorandum.

**Pipe Graphic Report of PLR** SVWRF JUNCTION BOX for **SVSD**

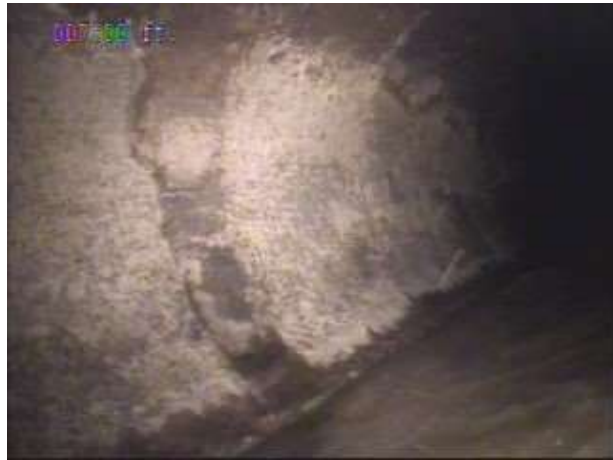
**Date:** 2019/08/16  
**Distance:** 7.0 Ft  
**Obs:** Surface Damage  
 Aggregate Visible

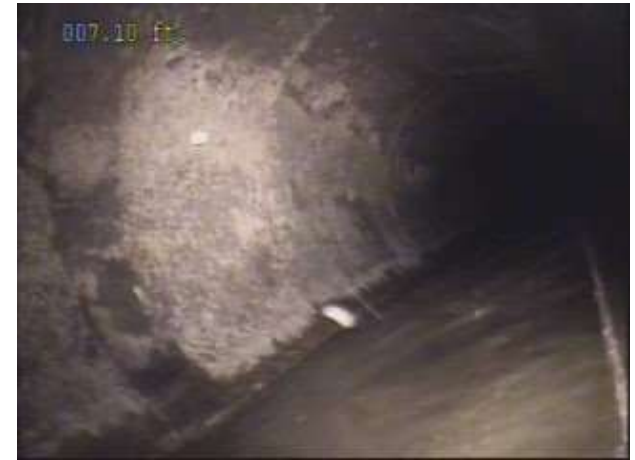
**Date:** 2019/08/16  
**Distance:** 7.1 Ft  
**Obs:** Surface Damage  
 Surface Spalling

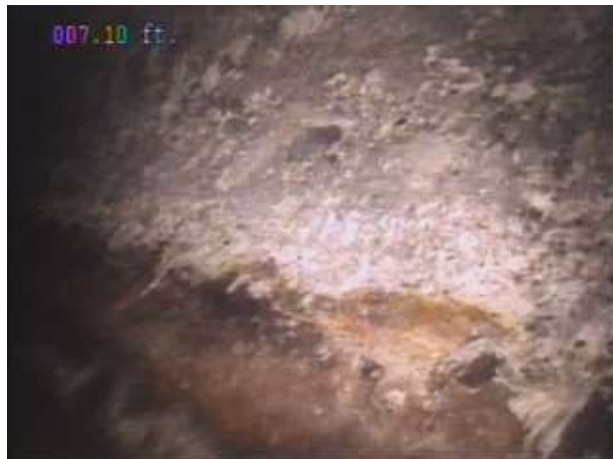
**Date:** 2019/08/16  
**Distance:** 7.1 Ft  
**Obs:** Surface Damage  
 Aggregate Visible

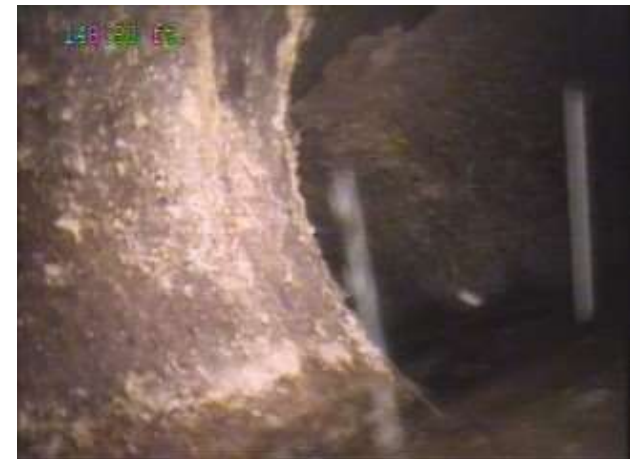
**Date:** 2019/08/16  
**Distance:** 148.4 Ft  
**Obs:** Surface Damage  
 Aggregate Visible

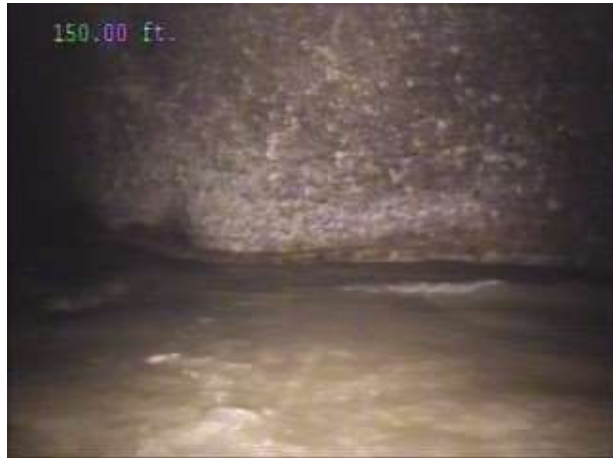
**Date:** 2019/08/16  
**Distance:** 150.0 Ft  
**Obs:** Surface Damage  
 Aggregate Visible

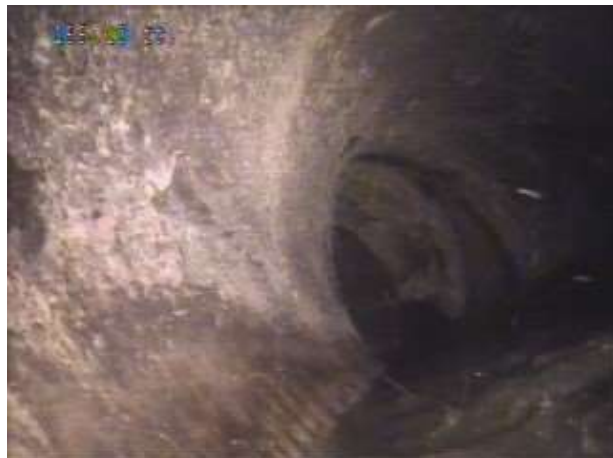
**Date:** 2019/08/16  
**Distance:** 154.4 Ft  
**Obs:** Surface Damage  
 Surface Spalling

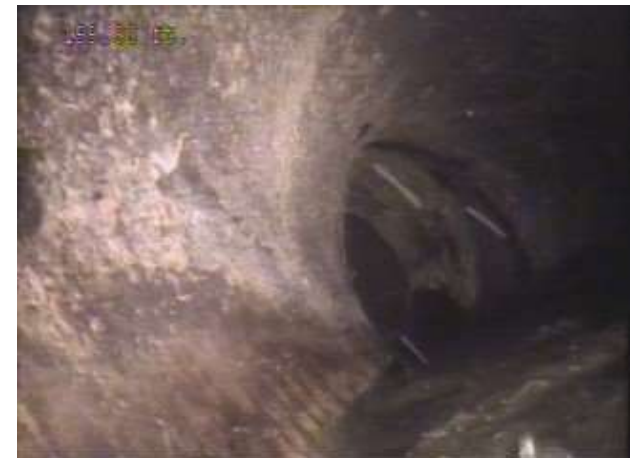
**Date:** 2019/08/16  
**Distance:** 161.1 Ft  
**Obs:** Surface Damage  
 Aggregate Visible

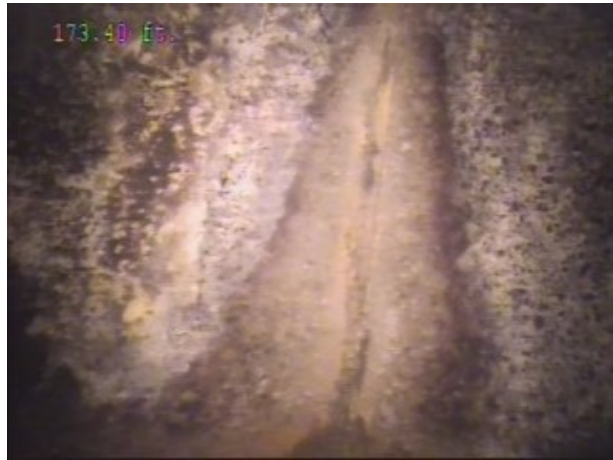
**Date:** 2019/08/16  
**Distance:** 173.4 Ft  
**Obs:** Infil Stain

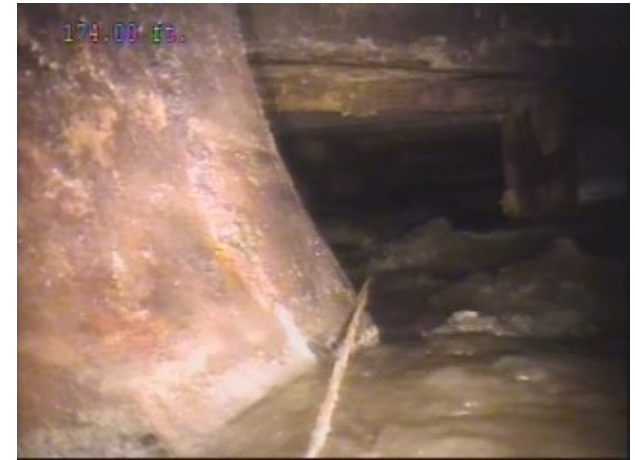
**Date:** 2019/08/16  
**Distance:** 174.0 Ft  
**Obs:** End of Pipe

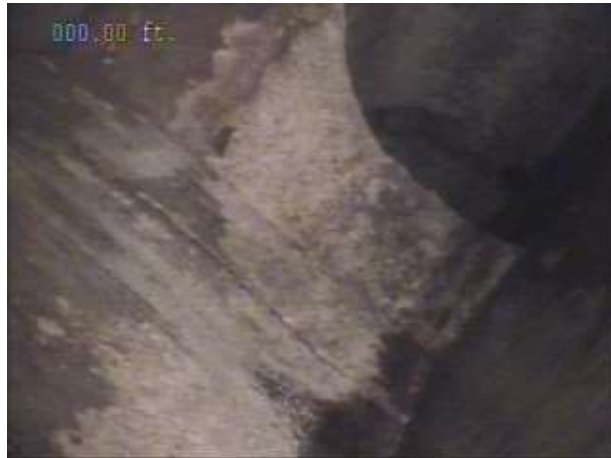
**Date:** 2019/08/19  
**Distance:** 0.0 Ft  
**Obs:** Surface Damage  
 Aggregate Visible

**Comments:**  
 WALL

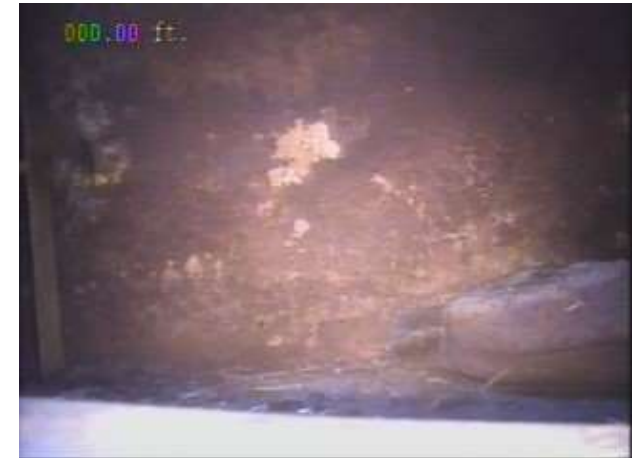
**Date:** 2019/08/19  
**Distance:** 0.0 Ft  
**Obs:** Surface Damage  
 Surface Spalling

**Comments:**  
 WALL

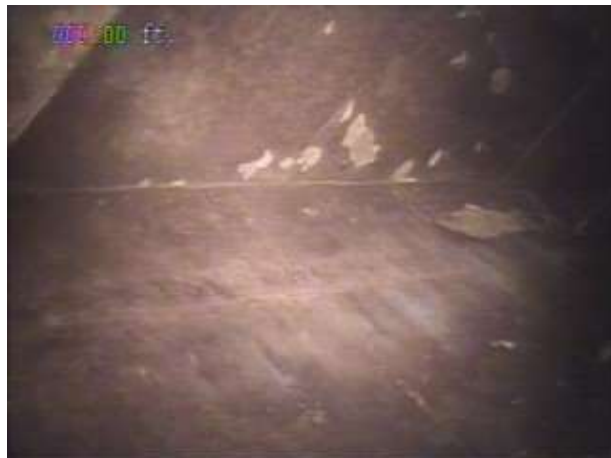
**Date:** 2019/08/19  
**Distance:** 0.0 Ft  
**Obs:** Surface Damage  
 Surface Spalling

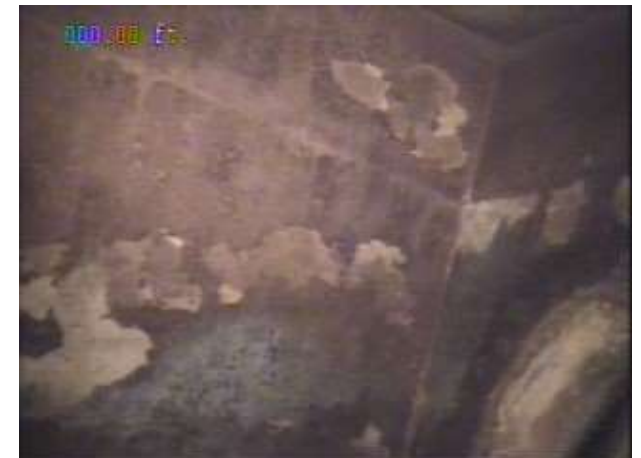
**Date:** 2019/08/19  
**Distance:** 0.0 Ft  
**Obs:** Surface Damage  
 Surface Spalling

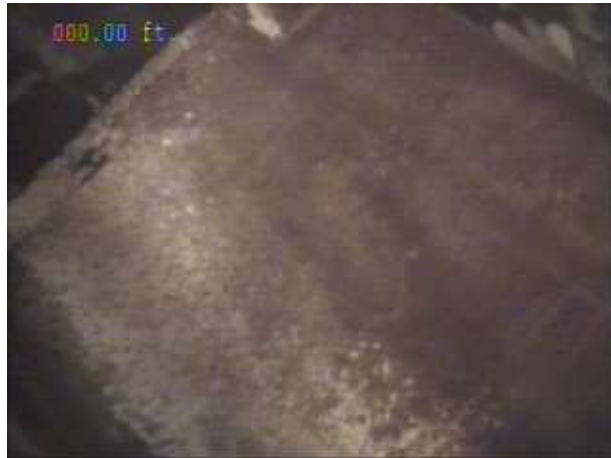
**Date:** 2019/08/19  
**Distance:** 0.0 Ft  
**Obs:** Surface Damage  
 Aggregate Visible

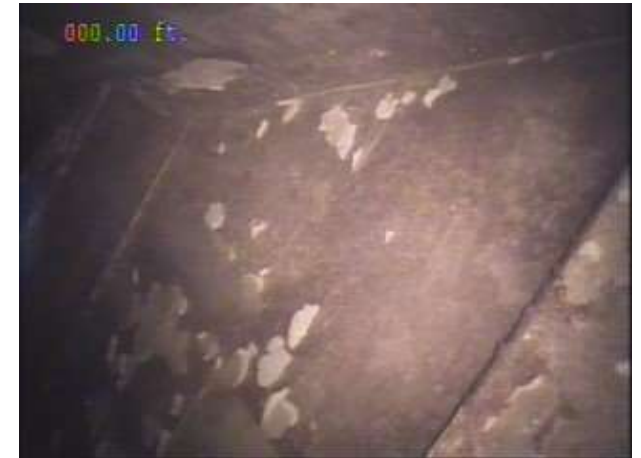
**Date:** 2019/08/19  
**Distance:** 0.0 Ft  
**Obs:** Surface Damage  
 Surface Spalling

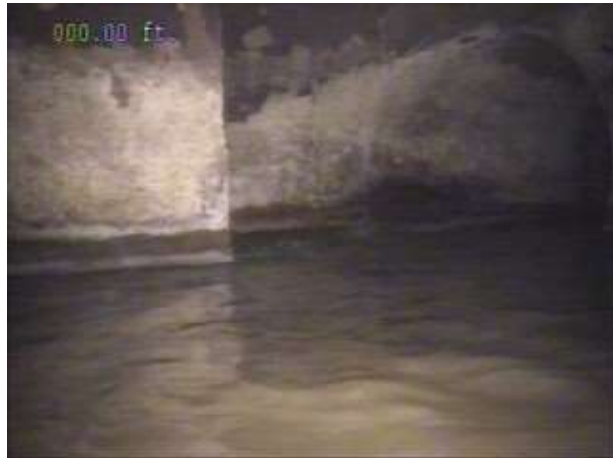
**Date:** 2019/08/19  
**Distance:** 0.0 Ft  
**Obs:** Surface Damage  
 Aggregate Visible

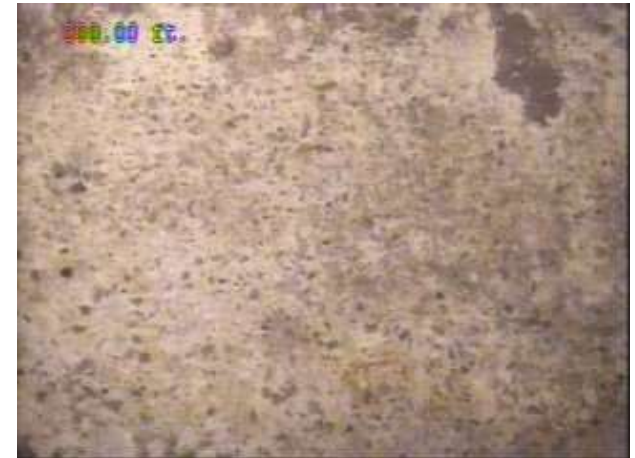
**Date:** 2019/08/19  
**Distance:** 0.0 Ft  
**Obs:** Surface Damage  
 Aggregate Visible

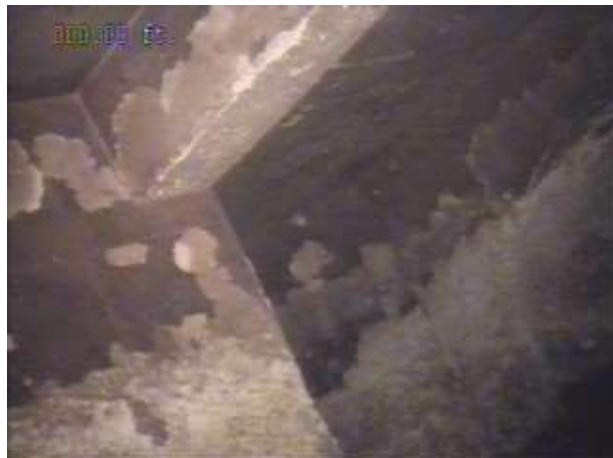
**Date:** 2019/08/19  
**Distance:** 0.0 Ft  
**Obs:** Surface Damage  
 Surface Spalling

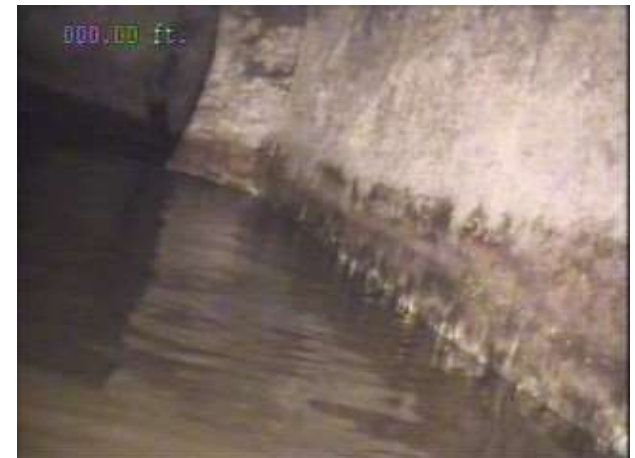
**Date:** 2019/08/19  
**Distance:** 0.0 Ft  
**Obs:** Surface Damage  
 Aggregate Visible

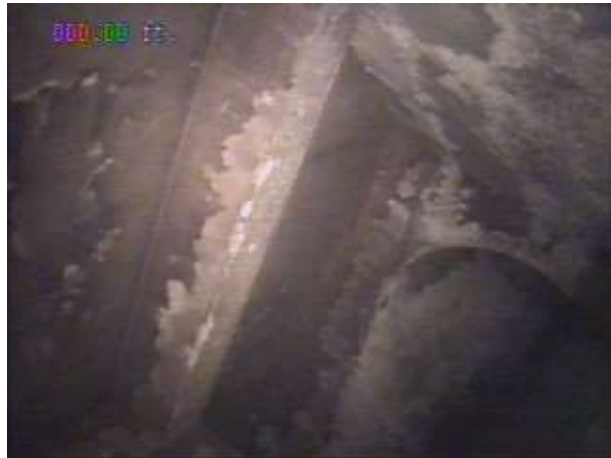
**Date:** 2019/08/19  
**Distance:** 0.0 Ft  
**Obs:** Surface Damage  
Surface Spalling
