CONDITION ASSESSMENT REPORT

SVSD River Bottom Trunk Line

Condition Assessment - Phase 1

South Valley Sewer District

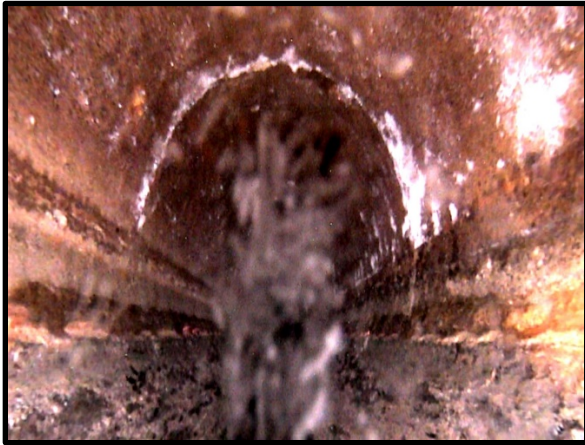
Figure 4 Surface Damage Aggregate Visible (SAV)
Pipe Segment: SL2477 at 0.3 ft

Most of the pipes in Phase 1 consist of RCP pipe materials. As such, the most common pipe defect was SAV in the existing RCP pipe material. Pipe defects are listed in Appendix C in the individual inspection reports for each pipe segment. Figure 8 shows the risk analysis for the pipe segments within the project. Each data point show and represents a pipe segment (manhole to manhole).

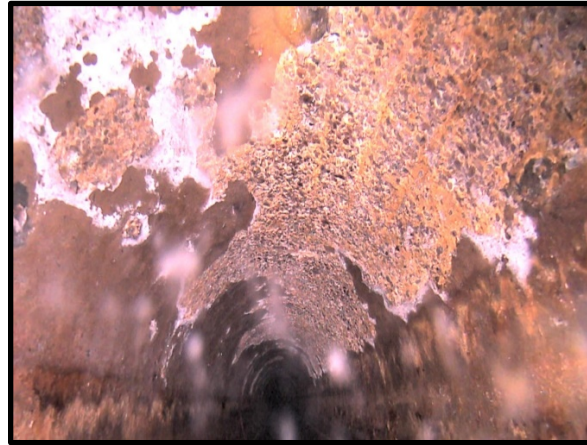
Surface damage is where some of the aggregate in the concrete pipe is visible and is projecting above the surface of the remaining concrete matrix.

Figure 5 Surface Damage Aggregate Projecting (SAP)
Pipe Segment: SL11054 at 271.4 ft

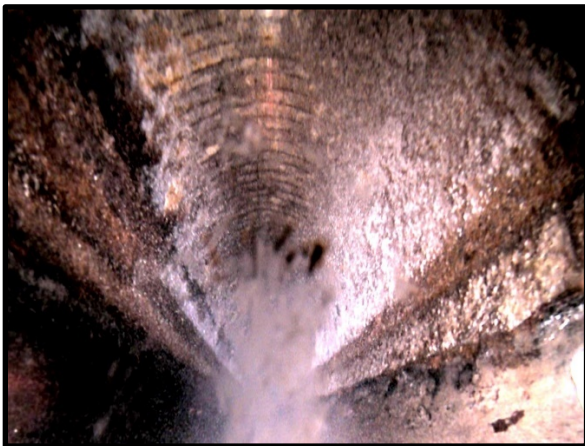
Surface reinforcement visible is where sufficient concrete is missing to enable the reinforcement to be visible. This type of defect is usually associated with H₂S damage.

Figure 6 Surface Damage Reinforcement Visible (SRV)
Pipe Segment: SL7660 at 6.6 ft

*SL7667	MH26	MH25	48	RCP	Replace in 5-10 Yr	CIPP
SL12465	MH7	MH47917	54	RCP	Replace in 5-10 Yr	CIPP
SL7660	MH6	MH5	54	RCP	Replace in 5-10 Yr	CIPP
*SL7661	MH5	MH4	54	RCP	Replace in 5-10 Yr	CIPP
SL7662	MH4	MH3	60	RCP	Replace in 5-10 Yr	CIPP

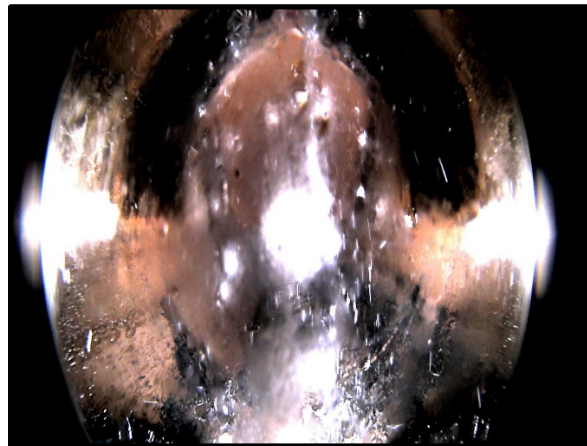
This type of infiltration gusher shows water entering the sewer pipe through a joint.

Figure 7 Infiltration Gusher Joint (IGJ)
Pipe Segment: SL8043 at 84.0 ft

SL4005	MH18278	MH111	42	RCP	Replace in 5-10 Yr	CIPP
SL12541	MH111	MH110	42	RCP	Reassess in 0-5 Yr	CIPP
MAP 4						
*SL8043	MH5514	MH5513	42	RCP	Replace in 0-5 Yr	CIPP
*SL8042	MH5513	MH47919	42	RCP	Replace in 0-5 Yr	CIPP
SL14634	MH87	MH45691	42	RCP	Reassess in 0-5 Yr	CIPP
SL11054	MH83	MH82	48	RCP	Replace in 5-10 Yr	CIPP
MAP 5						
SL41331-1	MH69	MH68	12	DIP	Replace in 5-10 Yr	CIPP
SL41331-2	MH69	MH68	12	DIP	Replace in 5-10 Yr	CIPP
SL41331-3	MH69	MH68	12	DIP	Replace in 5-10 Yr	CIPP
SL41331-4	MH69	MH68	12	DIP	Reassess in 0-5 Yr	CIPP
SL41331-5	MH69	MH68	12	DIP	Replace in 5-10 Yr	CIPP
MAP 6						
SL12503	MH49	MH50	54	RCP	Replace in 5-10 Yr	CIPP
SL12500	MH49	MH48	54	RCP	Replace in 5-10 Yr	CIPP
SL12493	MH22	MH21	54	RCP	Replace in 5-10 Yr	CIPP
SL12488	MH39	MH38	48	RCP	Replace in 5-10 Yr	CIPP
MAP 7						
SL12476	MH34	MH33	48	RCP	Replace in 5-10 Yr	CIPP
*SL12470	MH31	MH30	48	RCP	Replace in 5-10 Yr	CIPP
SL7665	MH27	MH9771	48	RCP	Reassess in 0-5 Yr	CIPP

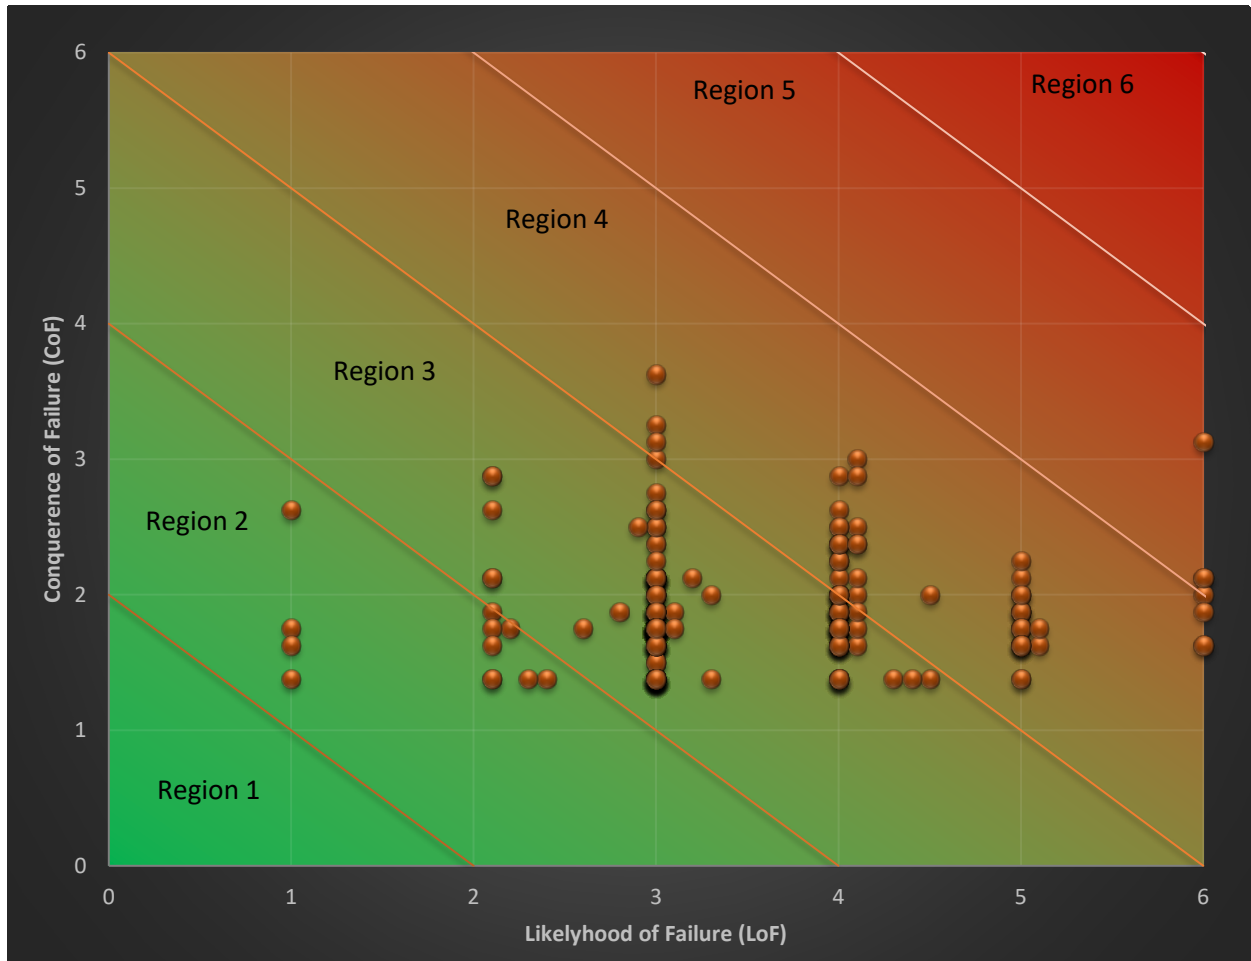
Figure 8 Risk Analysis (Pipe)

The results shown in Figure 8 indicate that the majority of the inspected pipe segments fall in regions 3 and 4 with a few outliers in regions 2 and 5. No pipe segments fall in regions 1 and 6. The following sections provide recommendations based on the strategy that pipe segments in Region 5 should be addressed first, then moving down to the left through the graph addressing pipe segments according to the region (highest first). Table 6 Segment Summary provides a tabulated summary of the region that pipe segments are categorized in based on their condition scores.

Region	# of Segments	Recommended Action
1	0	No Action
2	13	Reassess in 5-10 years
3	182	Reassess in 0-5 years
4	63	Replace/Rehabilitate in 5-10 years
5	4	Replace/Rehabilitate in 0-5 years
6	0	Immediate Action
Total # of Segments	262
