**Subject:** SVWRF Pipe & Structure

As part of the South Valley Sewer District's (SVSD) River Bottom Trunk Line Assessment - Phase 1, PEC received additional inspection videos containing a pipe segment and junction box to be assessed near the SVWRF. This pipe segment and junction box belongs to the South Valley Water Reclamation Facility (SVWRF), located at the north end of the SVSD project, see Figure 1. The pipe segment is an existing 96-inch diameter Reinforced Concrete Pipe (RCP) and the concrete junction box is divided by North and South access points. An individual pipe report and junction box report, showing the defects found, have been included as an attachment to this technical memorandum.

**Pipe Graphic Report of PLR** SVWRF JUNCTION BOX for **SVSD**

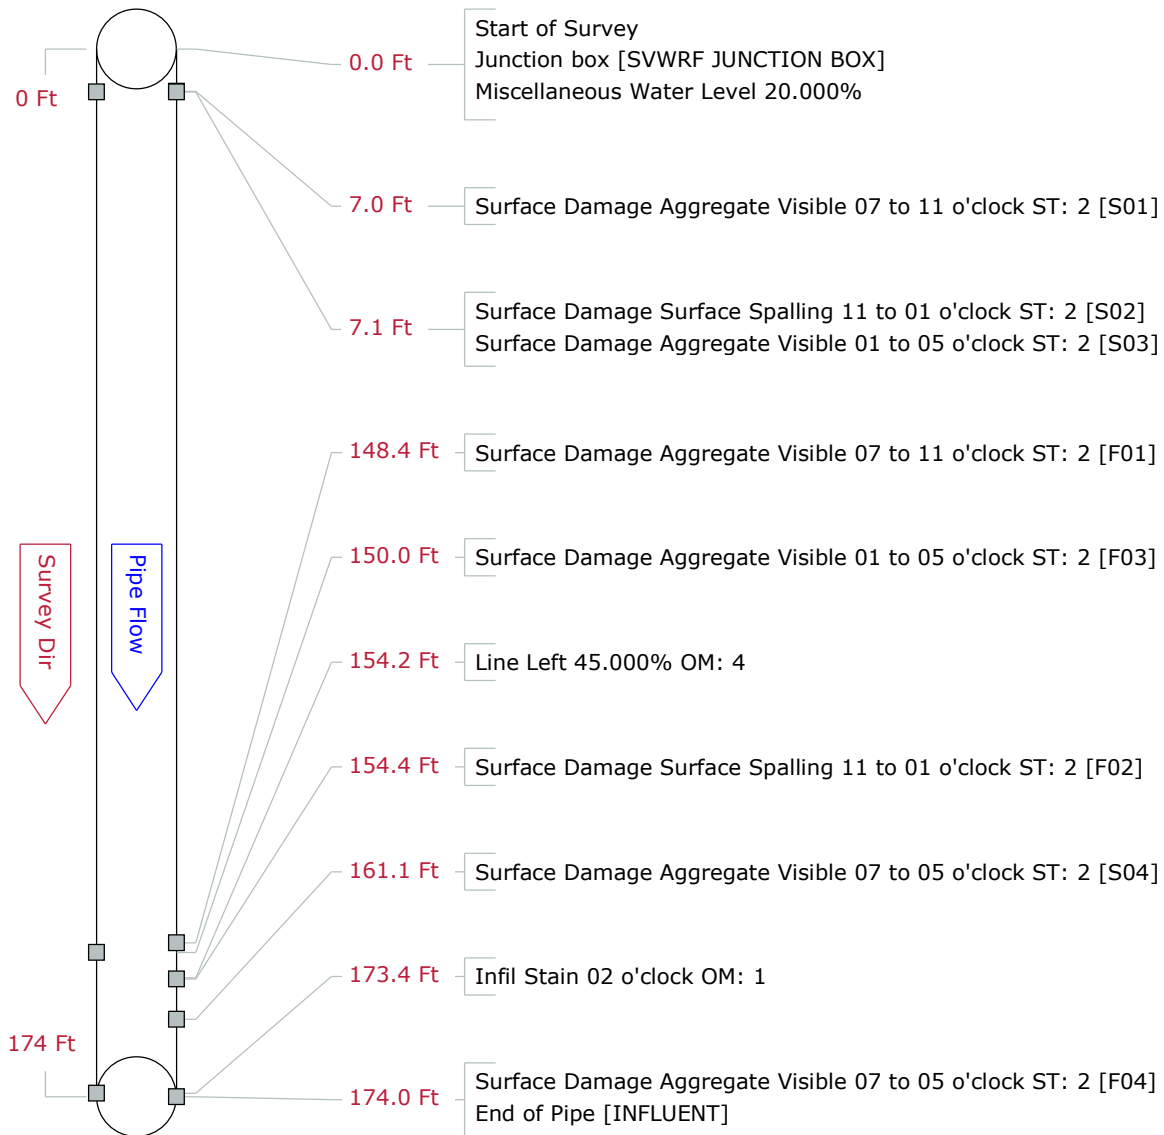
The primary material of both the pipe segment and junction box is RCP. During our assessment the worst structural defect code currently found in the pipe segment was aggregate visible. This defect was the worst structural defect detected in the junction box. The Operational & Maintenance defect found in the pipe segment was a “Left Alignment”, which according to NASSCO standards is a change in the pipe alignment to the left side. This O&M defect typically is not recommended for rehab since is considered a construction feature. The structural condition of both the pipe segment and junction box is expected to continue to deteriorate due to sewer gas exposure. Eventually, structural defects such as aggregate projecting, rebar visible, and rebar missing will be visible. Tables 1 and 2 show the structural and O/M defects found in the pipe segment and the junction box. More detailed information about the location and continuity of these defects is provided in the individual reports attached to this memo. Once all the structural and O&M defects were recorded, the pipe segment was scored and a “Quick Rating” was obtained. This Quick Rating shows the structural grade of the worst defect found in the pipe segment (first digit) and the number of times this defect was repeated (second digit). The third digit represents the second structural grade of the second worst defect, and the fourth digit represents the number of times this defect repeats. The aggregate visible defect score in pipe segment and junction box is a structural grade 2 (see Tables 1 and 2).

Typically, these defects would put the pipe and structure on a list to be re-inspected in 5 Years, however since there will be a rehabilitation project occurring immediately adjacent to this structure and pipe, PEC recommends that the SVWRF consider including this work in the rehabilitation project. The last column in Tables 1 and 2 shows the recommended action for pipe segment and junction structure.

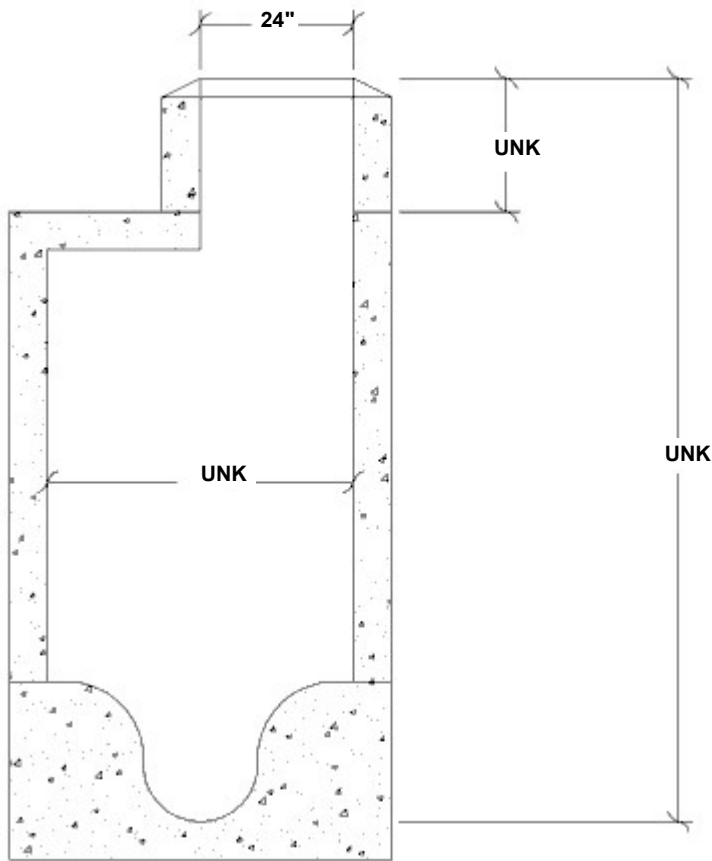
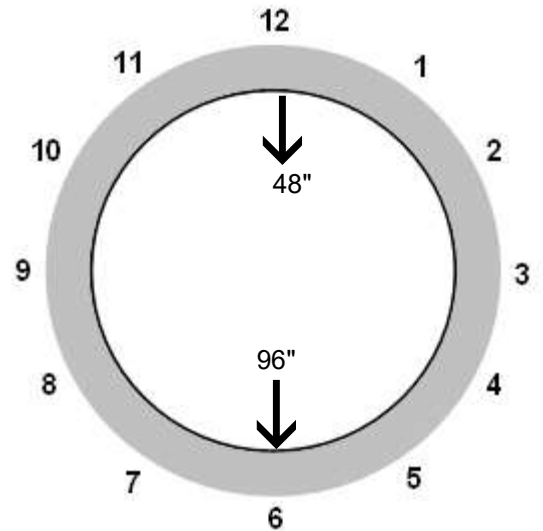
**SOUTH BOX**

**POOR - 3**

Distance	MH Component	PACP Defect	Cont. Defect	S/M/L	Inches		% Intrus.	JT	At From	To	Image Ref	Remarks
					1st	2nd						
	Chimney	SSS							12	12		
	Cone	SSS							12	12		
	Wall	SAV							12	12		
	Bench	SAV

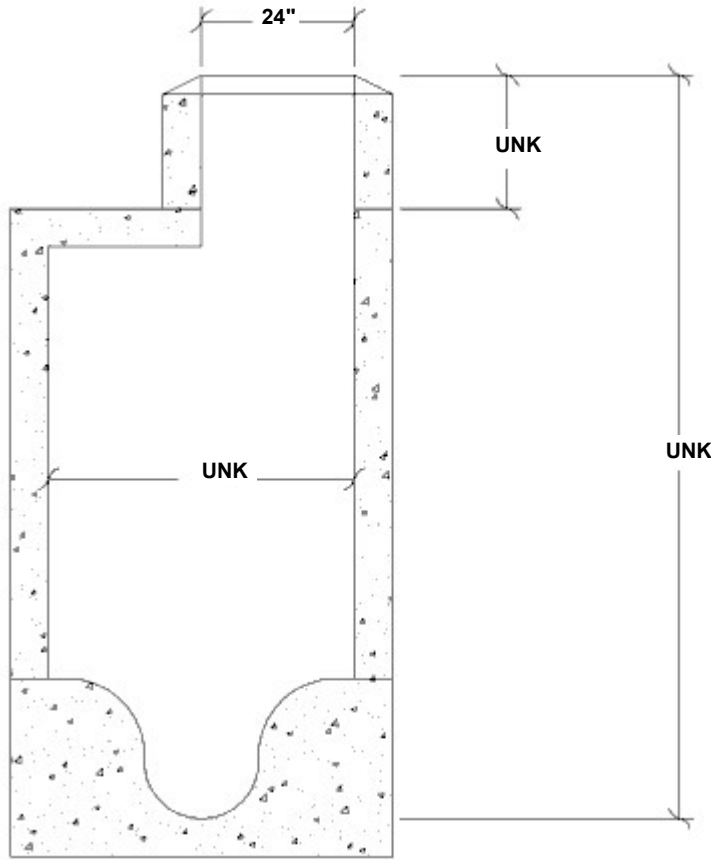
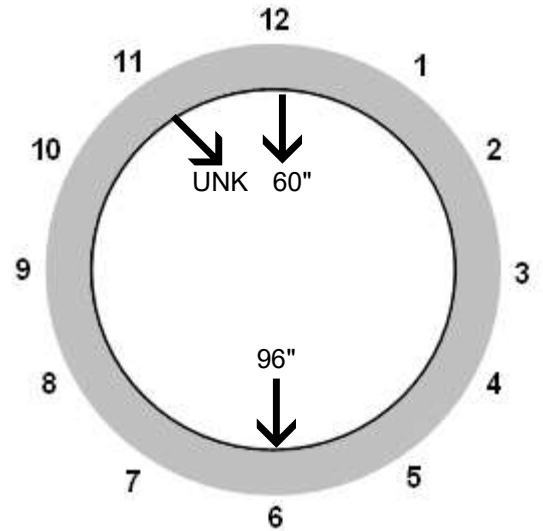
**NORTH BOX**

**POOR - 3**

Distance	MH Component	PACP Defect	Cont. Defect	S/M/L	Inches		% Intrus.	JT	At From	To	Image Ref	Remarks
					1st	2nd						
	Chimney	SSS							12	12		
	Cone	SSS							12	12		
	Wall	SAV							12	12		
	Bench	SAV
